General Information

Property Address Any Street
City Any Town State NH Zip 00000

Inspector Name Richard Burns
Company Name Shakes to Shingles Inspection Services
Company Address PO Box 2142
City Concord State NH Zip 3302
Phone (603) 415-1115 Fax (603) 375-2423
E-Mail info@shakestoshingles.com

Others Present Buyer, Buyer's Agent, Seller's Agent Property Occupied Vacant
Estimated Age 41 yrs Entrance Faces Street
Inspection Date April 29, 2005
Start Time 9:00 AM End Time 12:30 PM
Electric On Yes No Not Applicable
Gas/Oil On Yes No Not Applicable
Water On Yes No Not Applicable
Temperature 70
Weather Overcast Soil Conditions Dry
Space Below Grade Basement
Building Type Single family, Wood frame Garage Attached
Sewage Disposal Septic How Verified Seller's disclosure

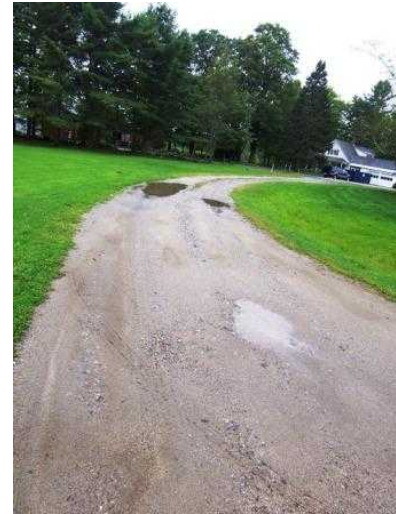
Fair/Maintenance Driveway: Gravel A few low spots are showing in the driveway.

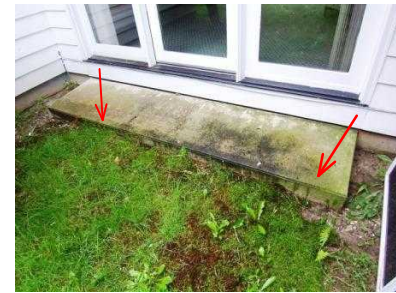
Fair/Maintenance Steps/Stoops: Concrete The rear stoop at the breezeway has settled slightly.

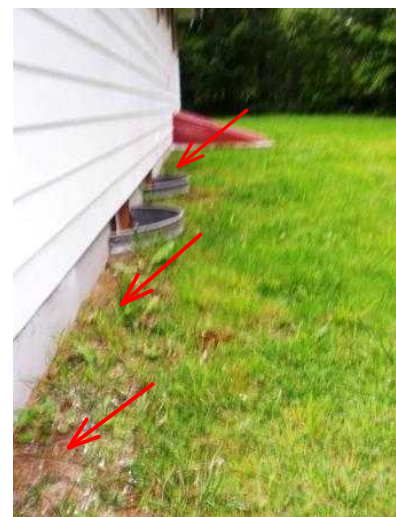
Fair/Maintenance Grading: Minor slope Low spots are showing along the foundation in the rear.

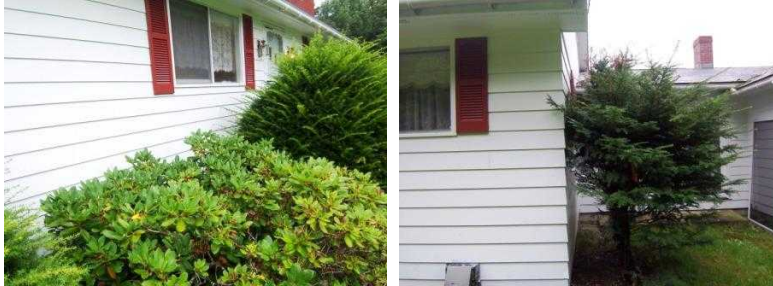
Fair/Maintenance Vegetation: Trees and shrubs The shrubs across the front and one on the left rear are coming in contact with the siding.

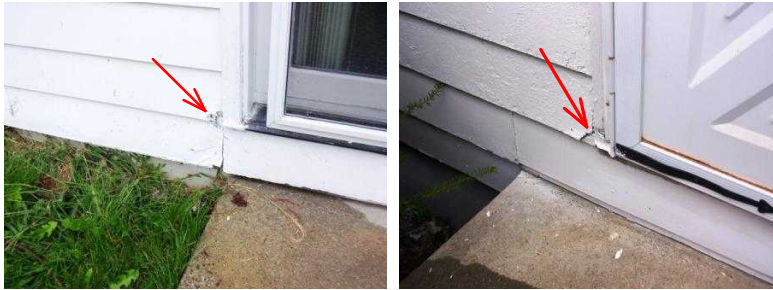
Fair/Maintenance Type: Hardboard The paint is peeling in a several places around the house. Deterioration is showing at the front door and at the left front between the garage and the breezeway. Minor damage is showing in the siding where the breezeway meets the house in the rear.

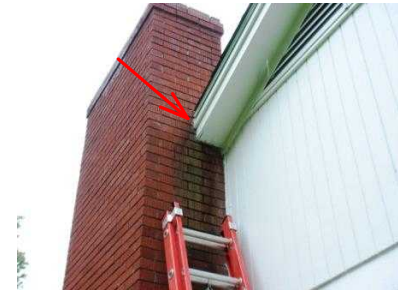
Fair/Maintenance Fascia: Wood Wood rot is present in the rake trim where it meets the chimney on the right side.

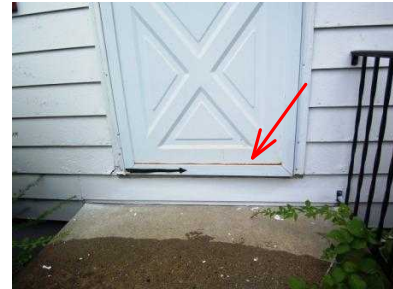
Fair/Maintenance **Screen/Storm Door:** Metal frame, Screen door, Storm door The front storm door sticks and is rusting at the bottom. The screen door in the rear has been removed.

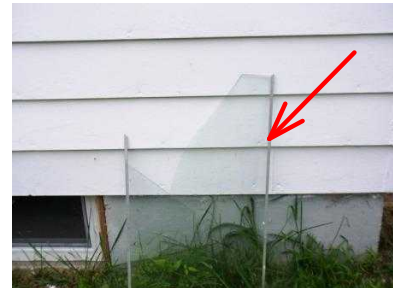
Good **Windows:** Sliding
Fair/Maintenance **Storm Windows:** Metal frame One storm window in front is loose; one on the right side is laying up against the house and is broken; and one in the rear is missing.

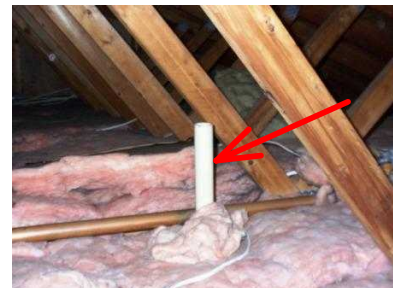
Areas Of Concern **Plumbing Vents:** Copper, PVC The newer plumbing vent for the downstairs bathroom is venting into the attic instead of outside.

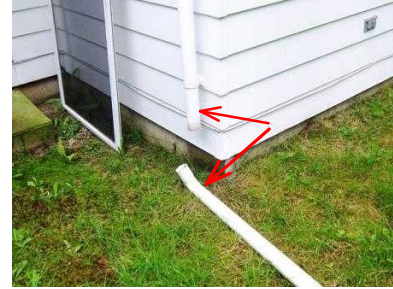
Fair/Maintenance Downspouts: Plastic One downspout in the rear is not attached.

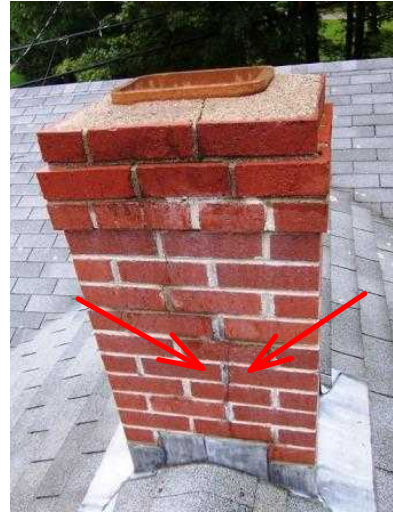
Left side Chimney

Fair/Maintenance Chimney: Brick Small cracks are showing in the top cap; moss is growing and a few cracks are present on the side. Recommend a weather cap and rodent screen at the top. Due to the inaccessibility of the flue, we are unable to fully evaluate the chimney.

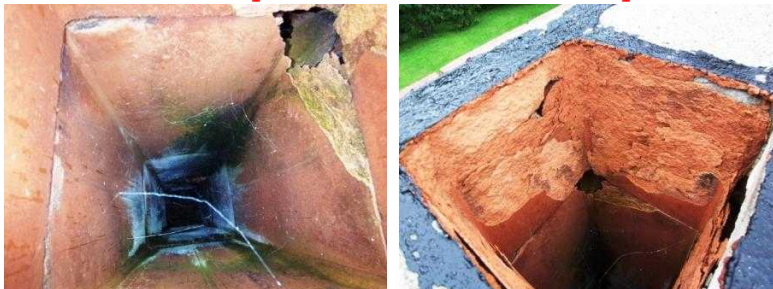
Right side Chimney

Areas Of Concern Chimney: Brick The top cap does not have crown and water is pooling on it. The fireplace flue is cracked and damaged at the top and a few tiles down. The top tile at the rear flue is deteriorating at the top. Recommend a weather cap and rodent screen at the top. Recommend further evaluation and repair. Due to the inaccessibility of the flue, we are unable to fully evaluate the chimney.

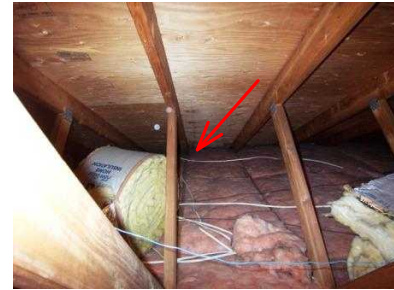
Fair/Maintenance Ventilation: Gable vents, Ridge and soffit vents Some of the soffit vents are partially covered with insulation.

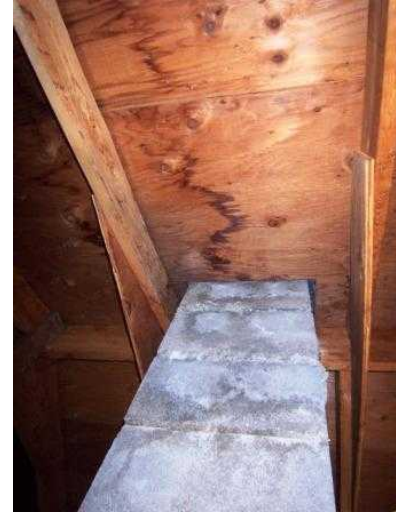
Fair/Maintenance **Moisture Penetration:** Previous water penetration noted
A small amount of daylight is showing around the chimney and some old stains are present.

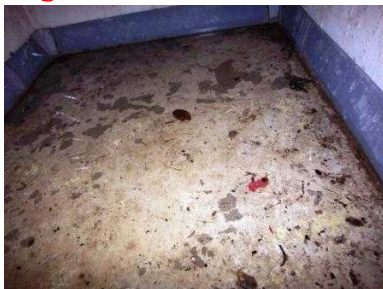
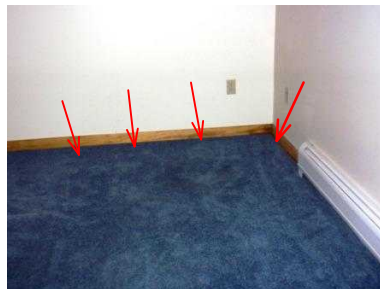
Areas Of Concern **Moisture Location:** Walls, Floor Standing water is present in the bulkhead area and moisture is present in the carpet across the rear wall in the right rear bedroom.

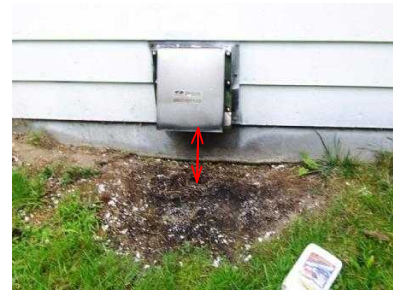
Fair/Maintenance Flue Pipe: Metal, Power vent **The flue pipe is less than 12" from the ground.**

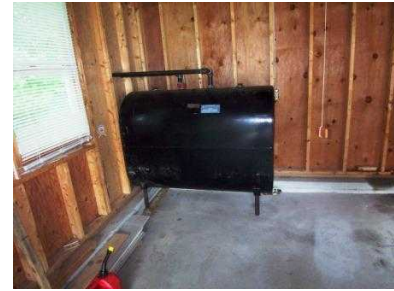
Areas Of Concern Fuel Tank: 275 gallon The oil tank is installed at the rear of the garage without any protection around it.

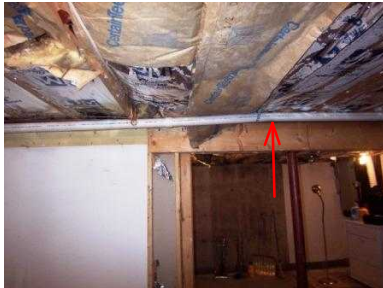
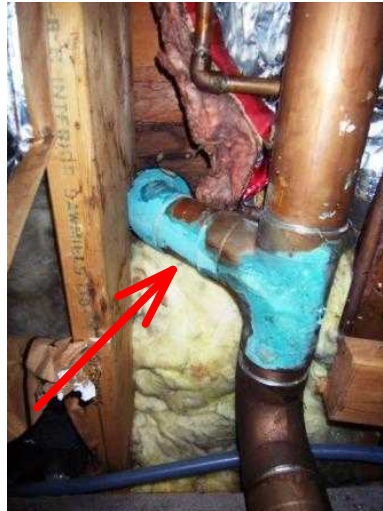
Good Service Line: ABS
Good Main Water Shutoff: At the pressure tank
Good Well Tank Shallow well pump/Pressure tank
Good Water Lines: Copper, Plastic PEX piping
Fair/Maintenance Drain Pipes: PVC, ABS, Copper One drain line from the laundry has an inadequate pitch and there are signs of previous seepage at the drain under the toilet.

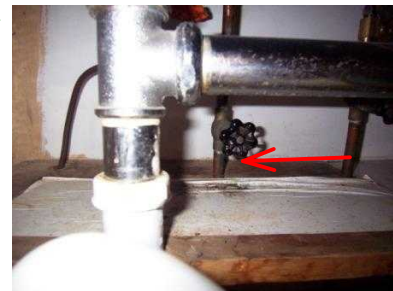
- Good Cooking Appliances: Maytag
- Good Ventilator: Broan, Exterior vent
- Fair/Maintenance Dishwasher: Kenmore The spring for the dishwasher door is either weak or disconnected causing it to drop down too quickly.
- Good Refrigerator: Kenmore The refrigerator is getting old but is functioning properly at this time.
- Good Sink: Stainless Steel
- Fair/Maintenance Electrical: 110 VAC outlets and lighting circuits Non-GFCI circuit -recommend GFCI circuit be installed
- Fair/Maintenance Plumbing/Fixtures: Metal, PVC An S-trap is in use under the sink (an S-Trap has the potential to siphon water out from the trap which may allow penetration of sewer gases into the dwelling) A small leak is showing at a shut off valve under the sink.

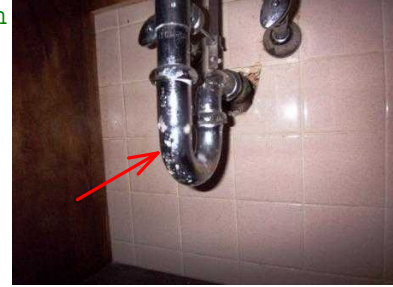
Good Walls: Drywall
 Good Floor: Tile
 Good Doors: Hollow core
 Good Windows: Sliding
 Good Electrical: 110 VAC GFCI outlets and lighting circuits
 Good Sink/Basin: Single vanity
 Fair/Maintenance Faucets/Traps: Metal Corrosion is present at the drain line under the sink.

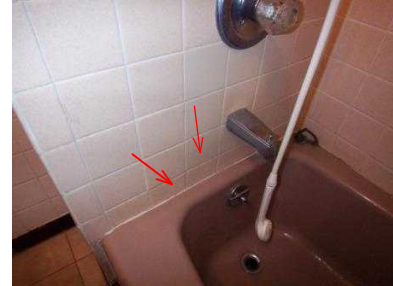
Fair/Maintenance Tub/Surround: Porcelain tub and ceramic tile surround
 A hollow sound is present behind some of the tiles near the tub spout.
