Thermography Report

Any Customer
Anytown, NH

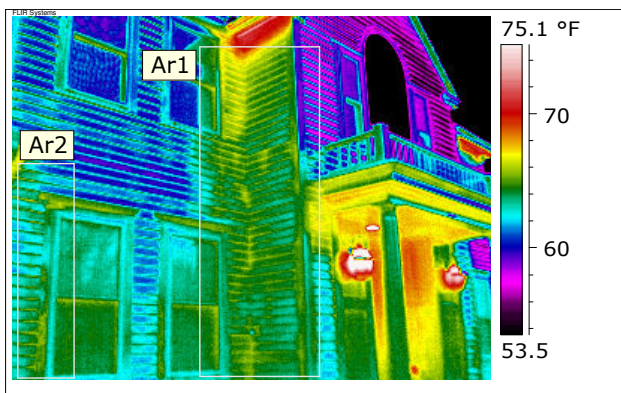
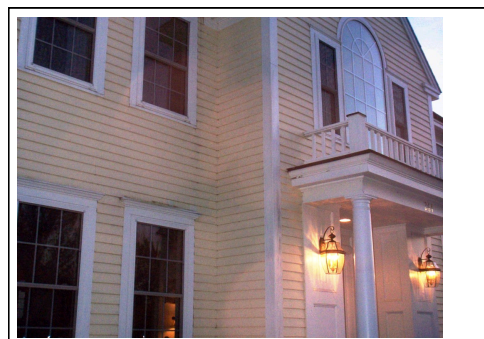
Picture 1. Captured at: Left front

Moisture Content: High moisture content
Comment: Elevated moisture in the yellow and green areas of area #1 and #2. The yellow sections have moisture than the green.
Recommendation: Recommend removing the siding to inspect and repair as needed.

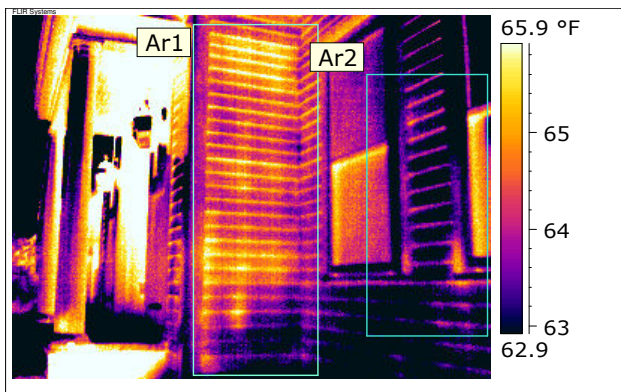
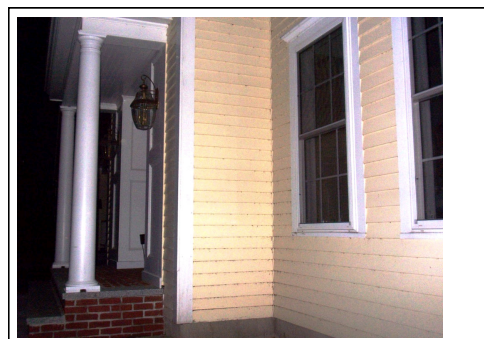
Picture 2. Captured at: Right front

Moisture Content: High moisture content
Comment: Elevated moisture in the lighter areas of #1 and #2.
Recommendation: Recommend removing the siding to inspect and repair as needed.
